**MARYLAND HISTORICAL TRUST  
DETERMINATION OF ELIGIBILITY FORM**

Property Name: Croom Historic District Inventory Number: P.G. 86A-27  
Address: Croom Road in vicinity of Duley Station  
Road and St. Thomas Church Road. City: \_\_\_\_\_ Zip Code: \_\_\_\_\_  
County: Prince George's USGS Topographic Map: Upper Marlboro, Brandywine  
Owner: Various Is the property being evaluated a district? X yes  
Tax Parcel Number: \_\_\_\_\_ Tax Map Number: \_\_\_\_\_ Tax Account ID Number: \_\_\_\_\_  
Project: Lake Marlton L.P. (East Marlton) Agency: U.S. Army, Corps of Engineers, Baltimore District.  
Site visit by MHT Staff: X no \_\_\_\_\_ yes Name: \_\_\_\_\_ Date: \_\_\_\_\_  
Is the property located within a historic district? X yes \_\_\_\_\_ no

Croom Historic District  
P.G. 86A-27

Continuation Sheet No. 1

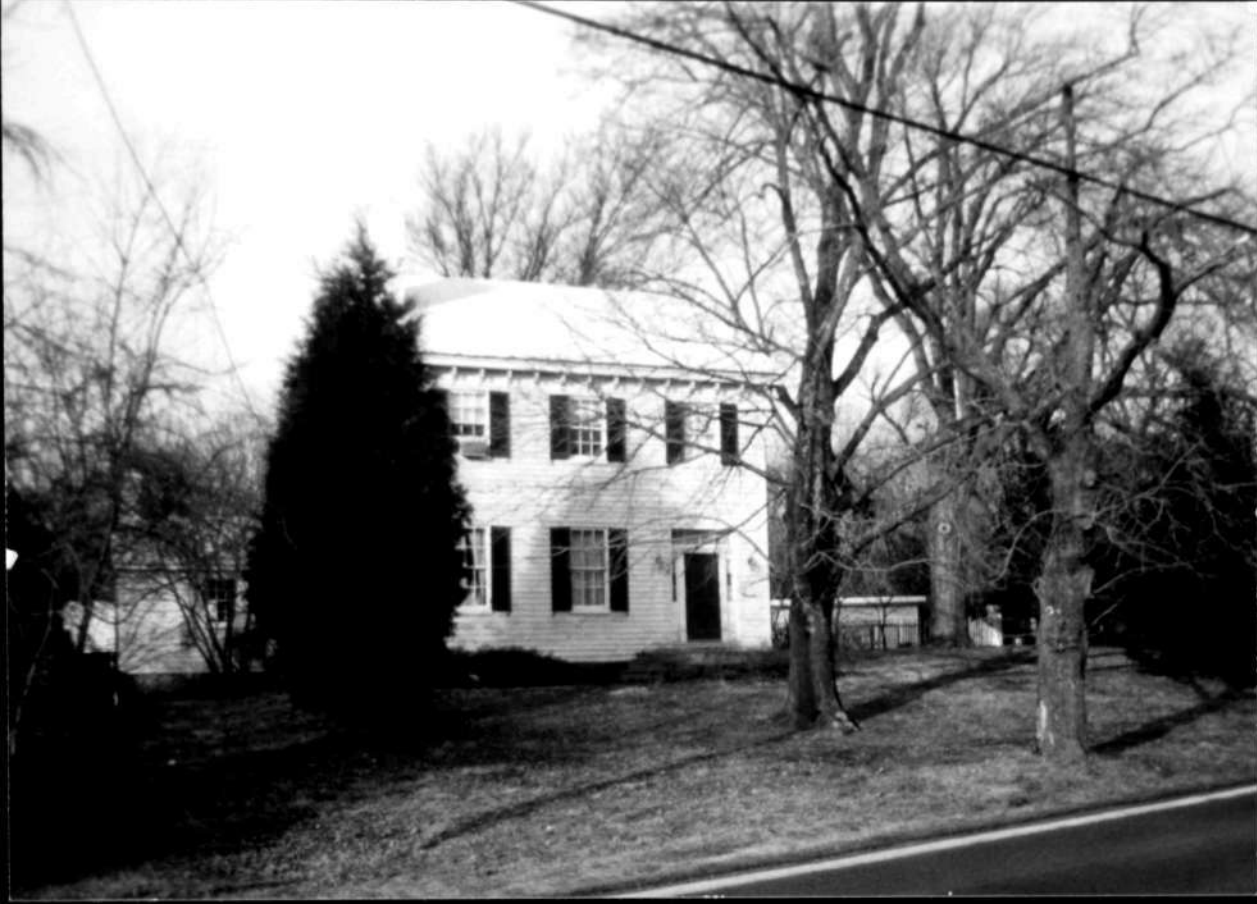
3 of 32.

The Coffren Store was constructed in 1853. It is a 3x2-bay, 2-story rectangular building with a saltbox type roof. The store has 6/6 double-hung sash windows covered with iron bars. The front porch has a shed roof and covers the entire length of the east side entrance. The front entrance to this store is centered, consisting of a pair of doors protected by the porch. The house lies south of the store, and is a 3x2-bay, 2-story modest Greek Revival Style house constructed in 1861, with Italianate brackets at the roofline and south interior gable end chimney. Windows of the house are 6/6 sashes, and siding is wood clapboard. The Coffren House and Store are stellar examples of architecture of the Croom Historic District.

Original Survey Number 3, PG 86-10, 11, John W. Coffren House,  
16007 Croom Rd. (C), View to West.

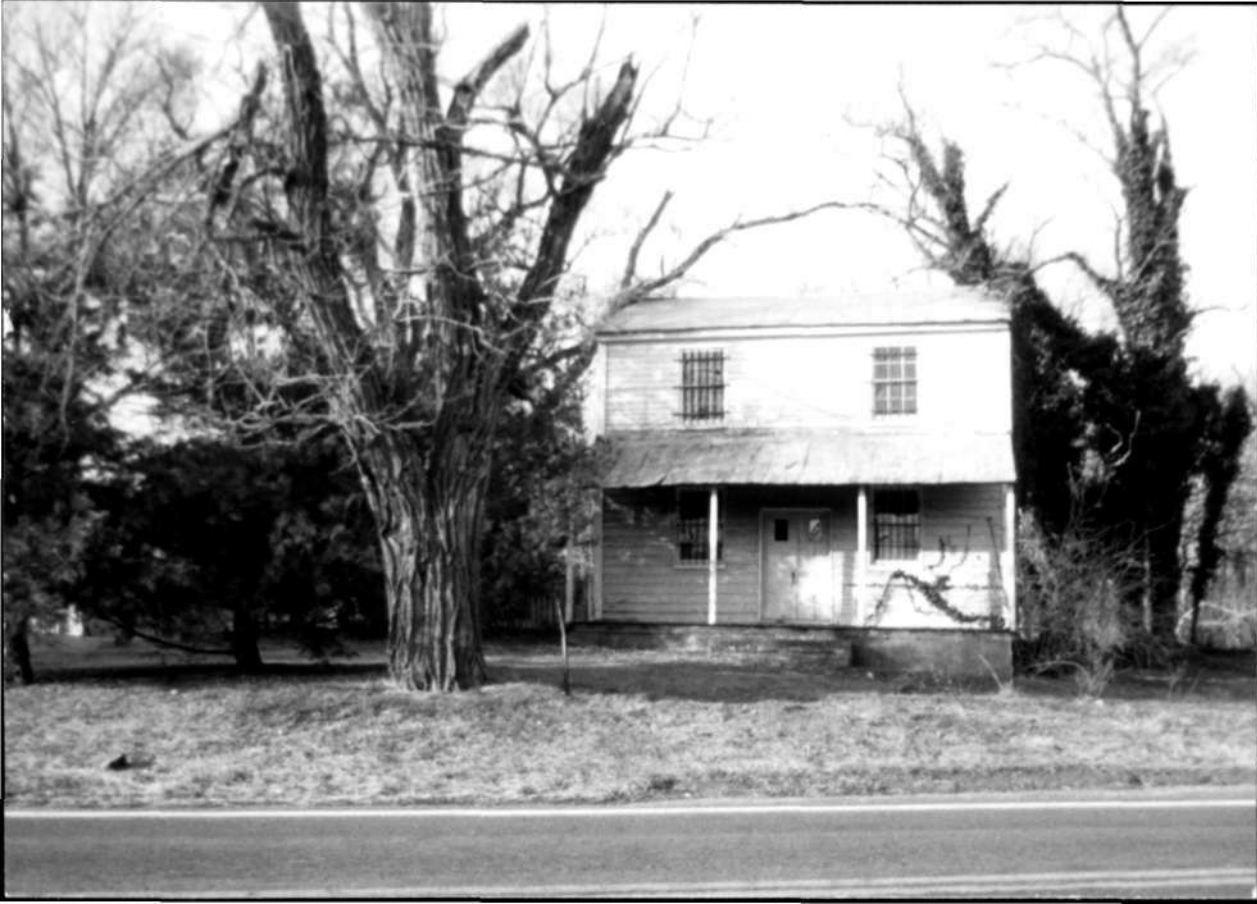
4 of 32

Original Survey Number 3, PG 86-10, 11, John W. Coffren Store,  
10007 Croom Rd.(C), View to West.

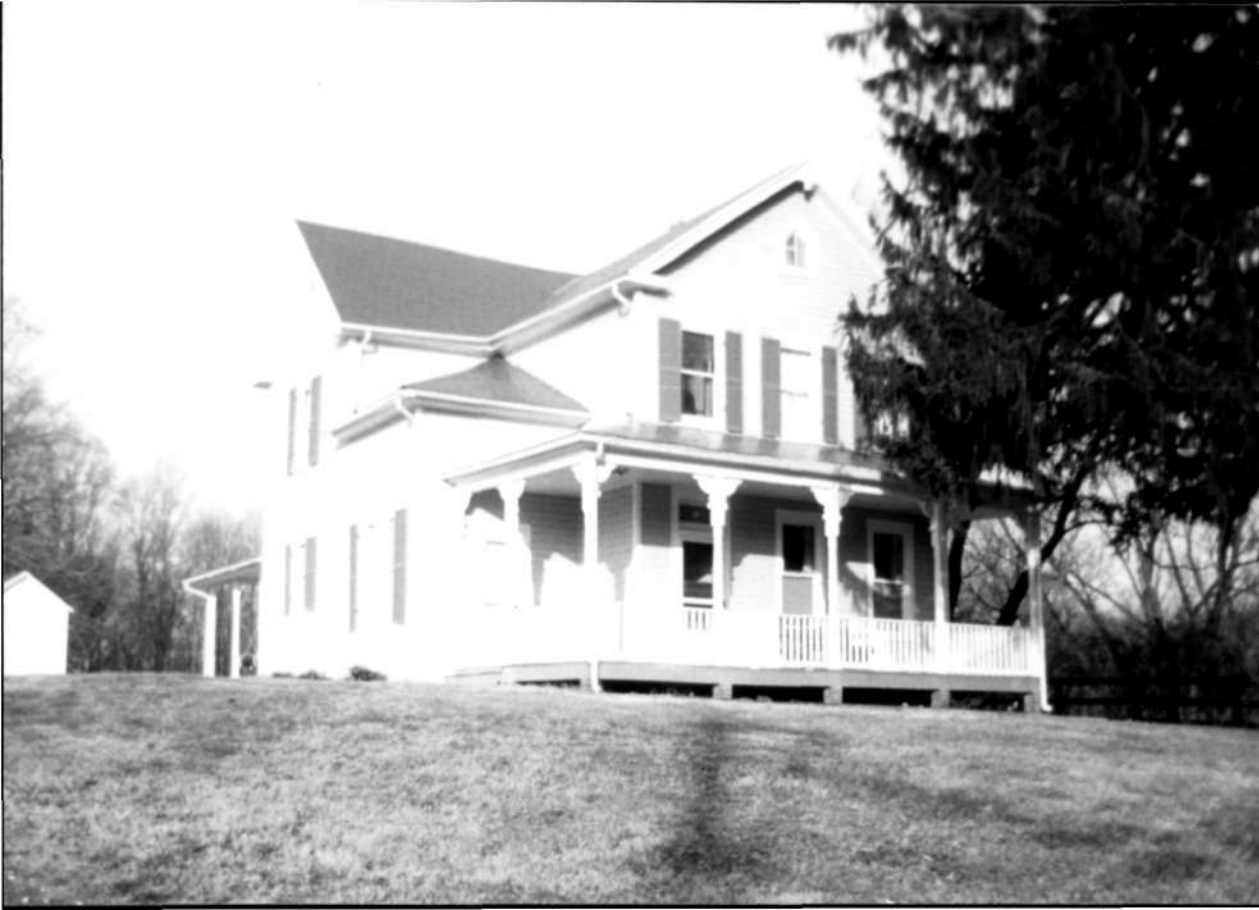
5 of 32

Constructed in 1893, this house is a 2 1/2 story cross-gable frame dwelling with 1-story bracketed entrance porch on the front, or east façade. Clad with asbestos shingles in the 1980s, the house is not clad with clapboard and has been restored to a remarkable condition. It is a primary resource of the Croom Historic District.

Original Survey Number 4, PG 86A-6, Dr. William H. Gibbons House,  
10205 Croom Rd. (C), View to Northwest.

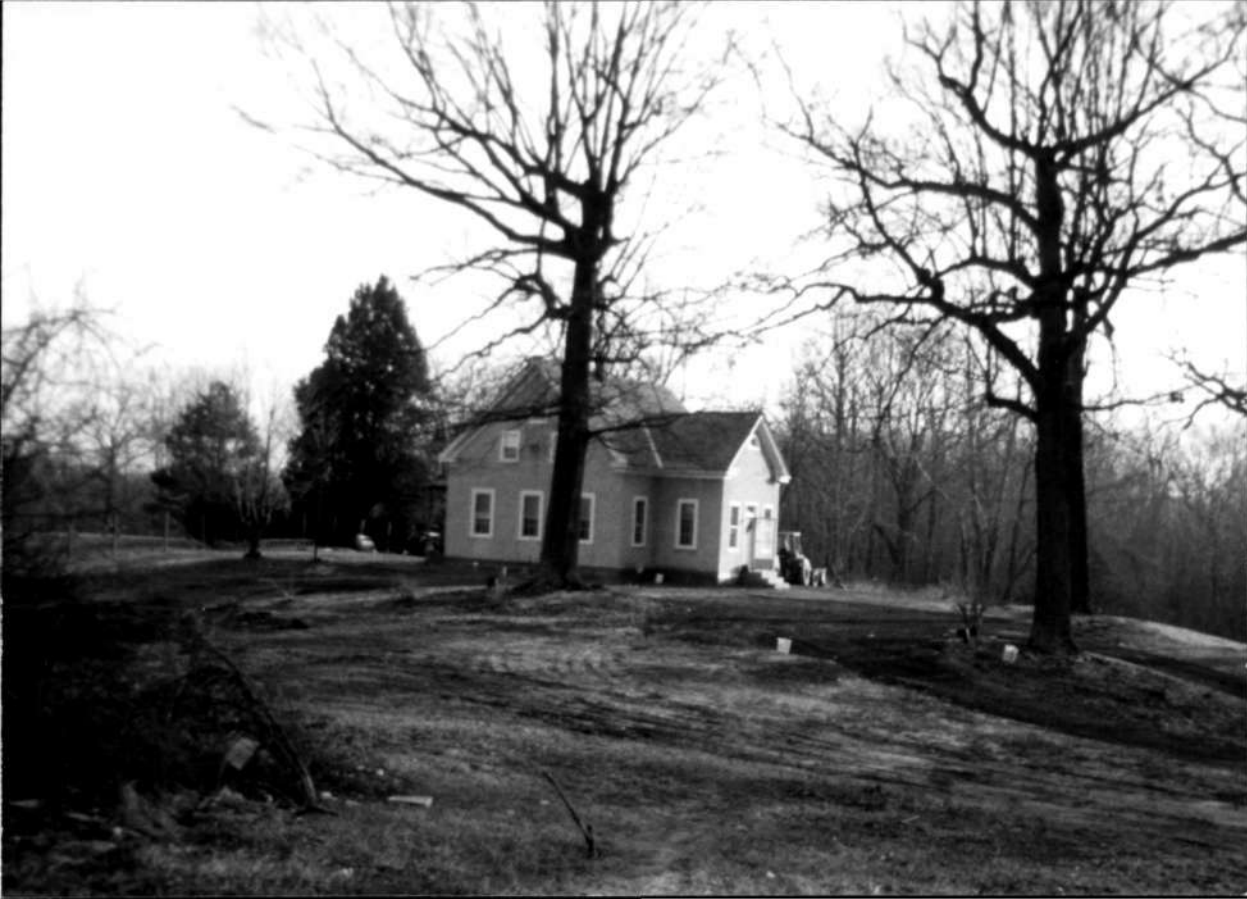
6 of 32

This building is a 1 1/2-story, cross-gable building with a central entrance bay on its south façade. Clad with stucco, the house sits back from Croom Rd. Originally a 1-room schoolhouse, it was partitioned in the 1930s and converted to a dwelling. A modest Greek Revival Style building, it remains unchanged since its original survey in 1986.

Original Survey Number 5, P.G. 86A-9, Old Croom School,  
10100 Croom Rd. (C), View to East.

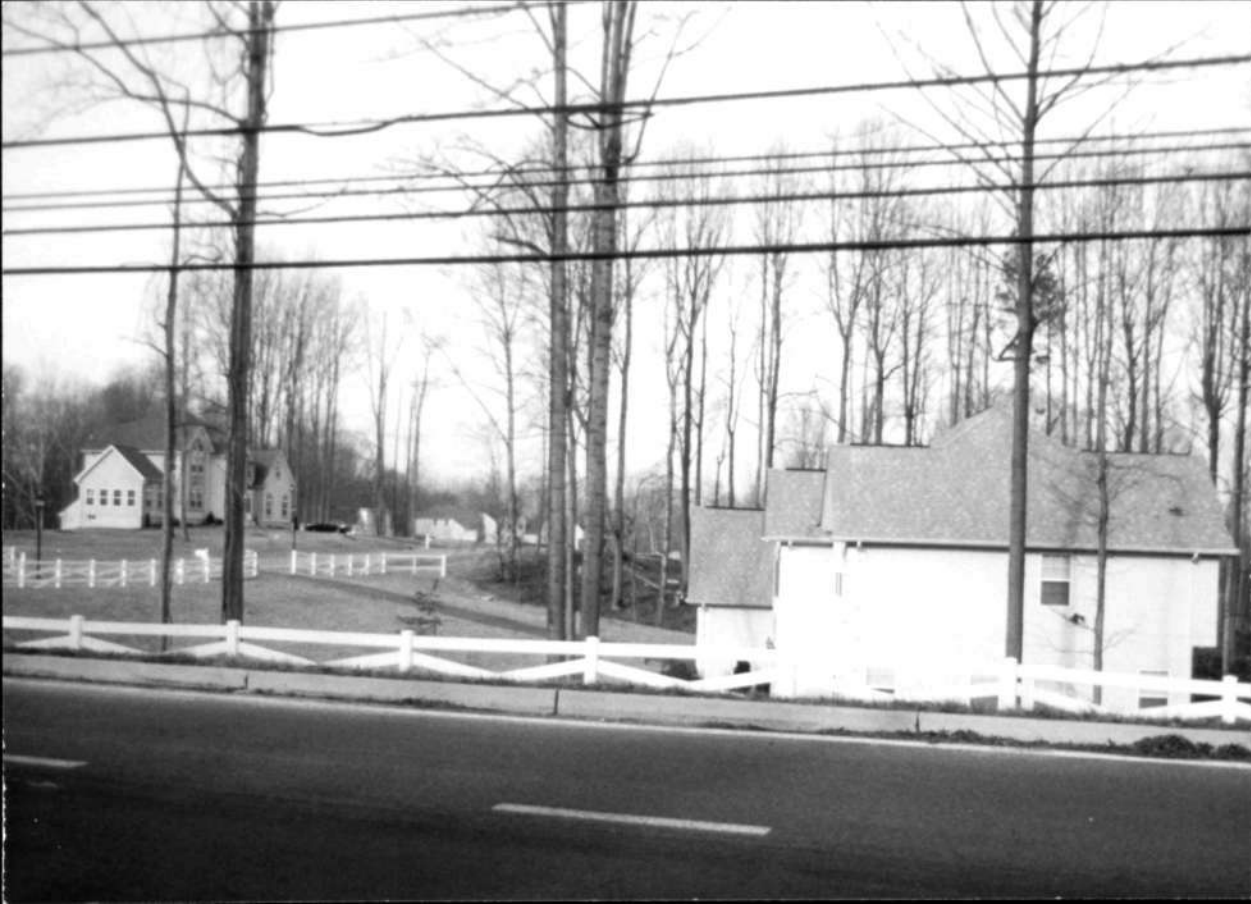
7 of 32

This resource, once a significant I-house and contributing resource to the district, has been demolished and the property that surrounded this dwelling is now the site of several new houses under construction as part of a residential development.

Photograph of the new residential development known as "Croom Estates"  
that is currently under construction. View to West.

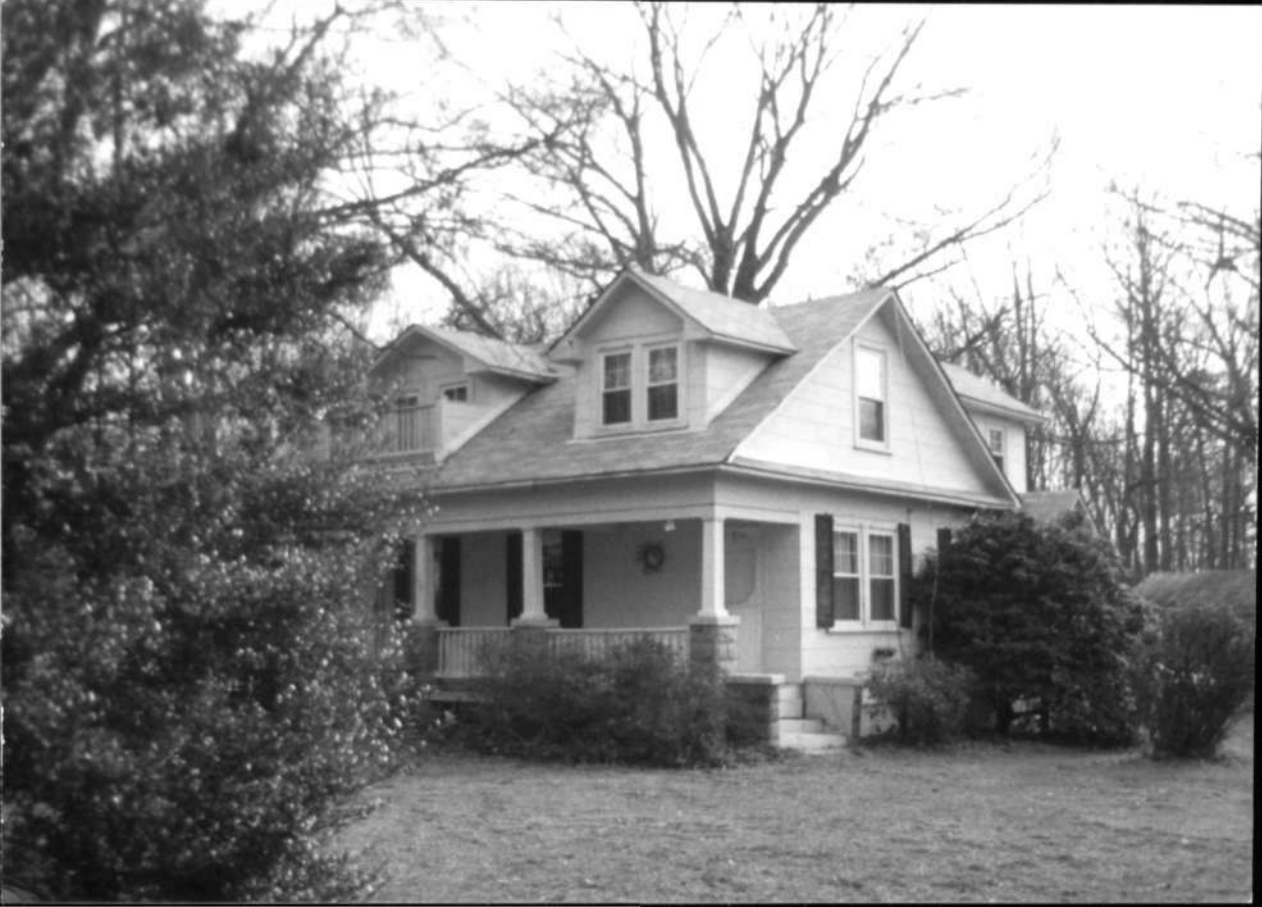
8 of 32

Originally considered a contributing resource to the district, this 1 ½-story, 3x2-bay bungalow is at the northern end of the original district as surveyed in 1986. The buildings in this section are markedly different in style from those of the southern portion of the survey, having early 20<sup>th</sup> century Craftsman Style influences. This section of the survey district is cut off from the earlier buildings in Croom by the presence of a new housing development currently being constructed on the west side of Croom Rd. just south of Croom Airport Rd. The new development and the loss of open space, as well as the presence of a large percentage of non-contributing mid-to-late 20<sup>th</sup> century structures diminishes the agricultural/rural landscape. The structures in this area and its landscape cannot be considered a contributing resources to the Croom Historic District.

Original Survey Number 6, 9312 Croom Rd. (NC), Bungalow  
outside of re-defined boundary north of new "Croom Estates"  
development, View to Northeast.

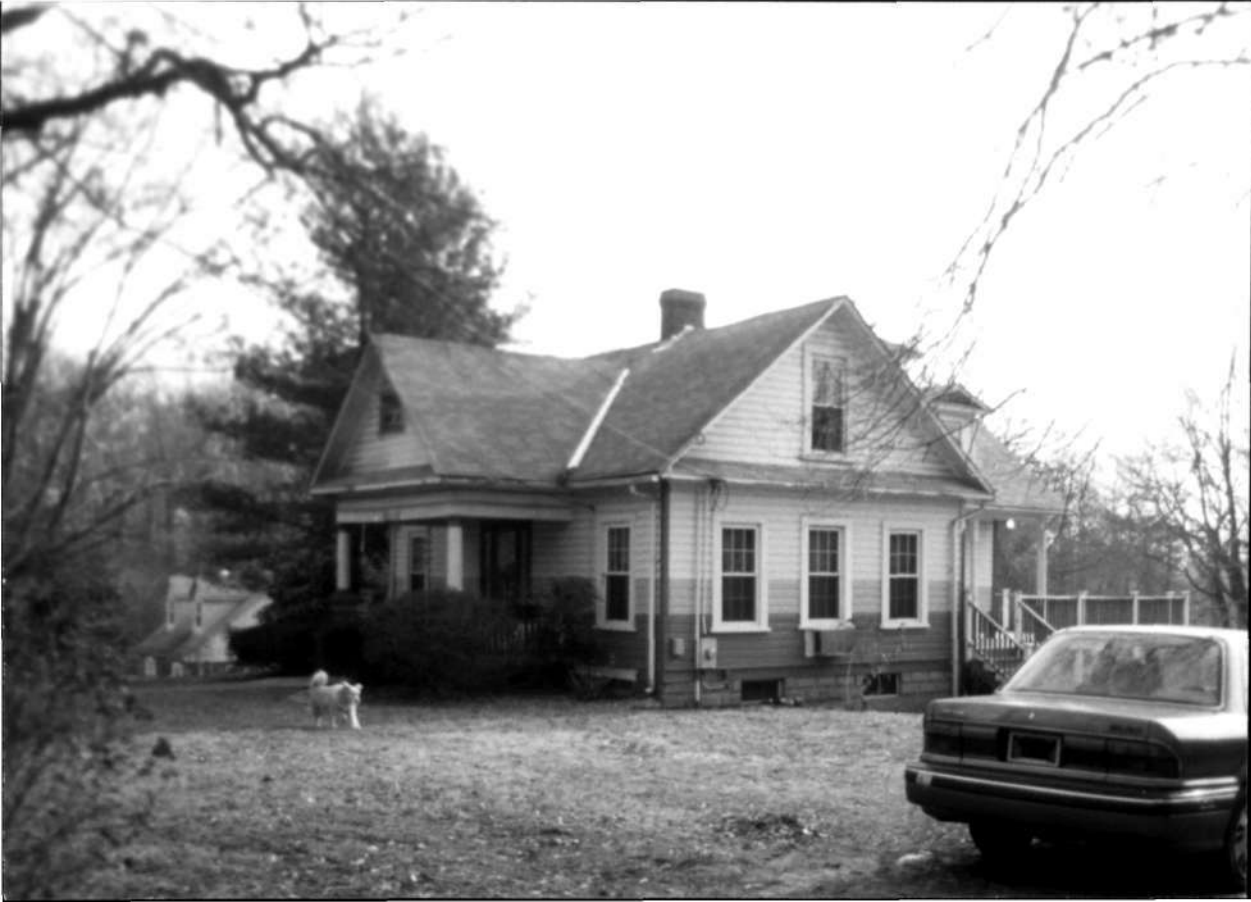
9 of 32

This 3x2-bay 1 ½-story cottage was probably constructed in the 1920s. The buildings in this section are markedly different in style from those of the southern portion of the survey, having early 20<sup>th</sup> century Craftsman Style influences. As previously stated, this section of the survey district is cut off from the earlier buildings in Croom by the presence of a new housing development currently being constructed on the west side of Croom Rd. just south of Croom Airport Rd. and cannot be considered contributing resources to the Croom Historic District.

MD SHPO  
Original Survey Number 9, 9402 Croom Rd. (NC). Cottage outside of  
re-defined boundary north of new "Croom Estates" development,  
View to Northeast.

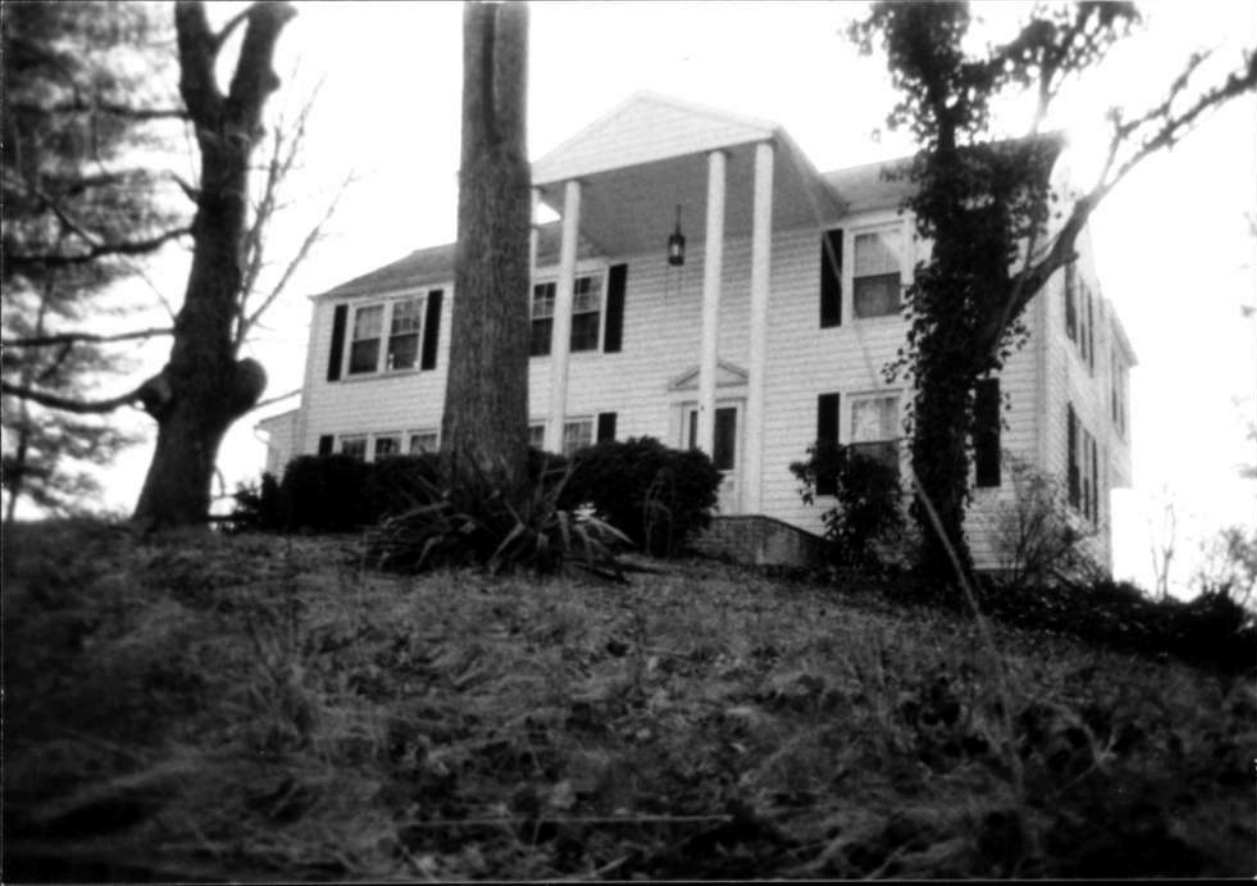
10 of 32.

This 2-story, 4x1-bay dwelling with multiple additions to the rear and concrete block foundation. Windows are replacement 1/1 sashes. This building lacks the integrity necessary to contribute to the district, and is not included in the re-defined boundaries of the district.

Original Survey Number 11, 9410 Croom Rd. (NC). Heavily altered dwelling north of new "Croom Estates" development, view to Northeast.

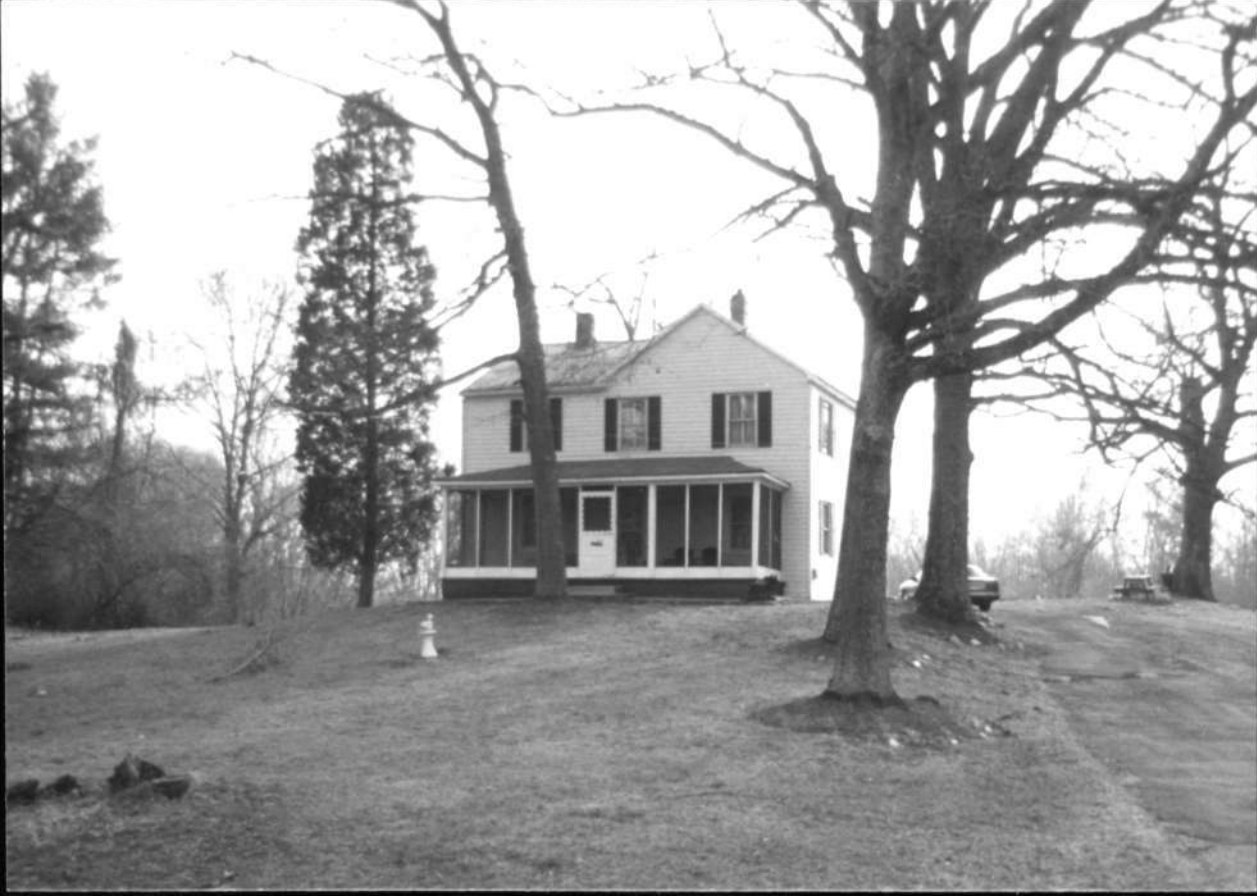
11 of 32

This 2-story, frame building with cross gable dates from around 1900. It is clad with vinyl siding and has 2/2-double-hung windows. Each gable ridge has an interior corbelled brick chimney. The front of the house has a full-length screened in porch with hip roof. This house, despite its vinyl siding, retains its original design and wood 2/2 windows, as well as metal roof. It possesses adequate integrity to be

considered a contributing resource to the historic district. This house represents the northern terminus of the re-defined boundaries of the Croom Historic District.

Original Survey Number 13, 9500 Croom Rd. (C), View to Northeast.

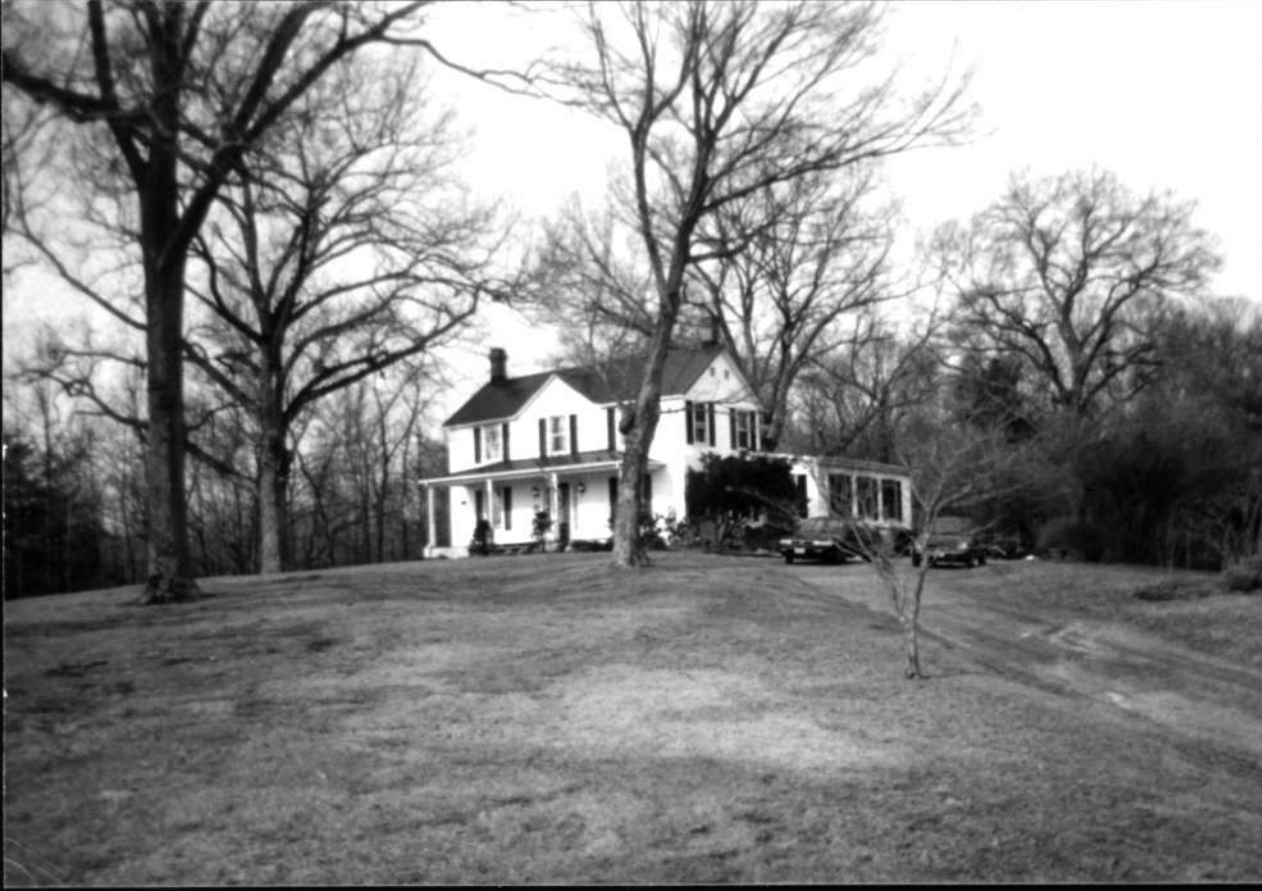
12 of 32

This is a 3x2-bay, frame house with a "T" shaped plan. Although clad with vinyl siding, it retains its original basic design, retaining original 2/2-double hung sash windows, brick chimneys, and metal roof. It is a contributing resource to the historic district.

Original Survey Number 19, PG-82A-31, Brooks-Cox House,  
9601 Croom Rd. (C), View to West.

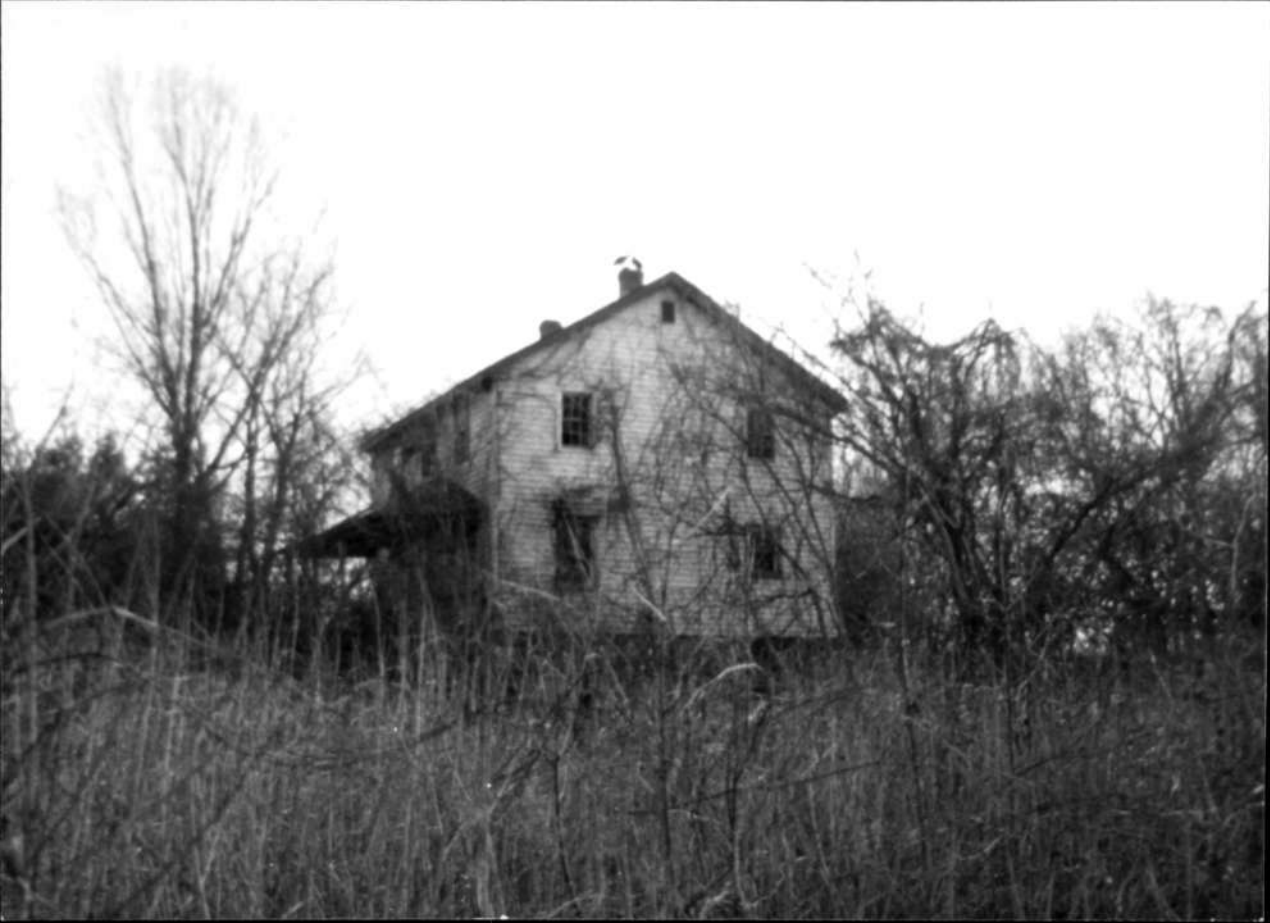
13 of 32

This is a 3x2-bay dwelling constructed around 1900 with a hip roofed front porch, 6/6 double-hung windows, and two interior end chimneys. Although the previous survey stated that the house had asbestos siding, it is clad with clapboard and has an asphalt shingle roof. The dwelling is vacant, but possess a high integrity of materials, design, and workmanship.

Original Survey Number 22, 9604 Croom Rd. (C), View to Northeast

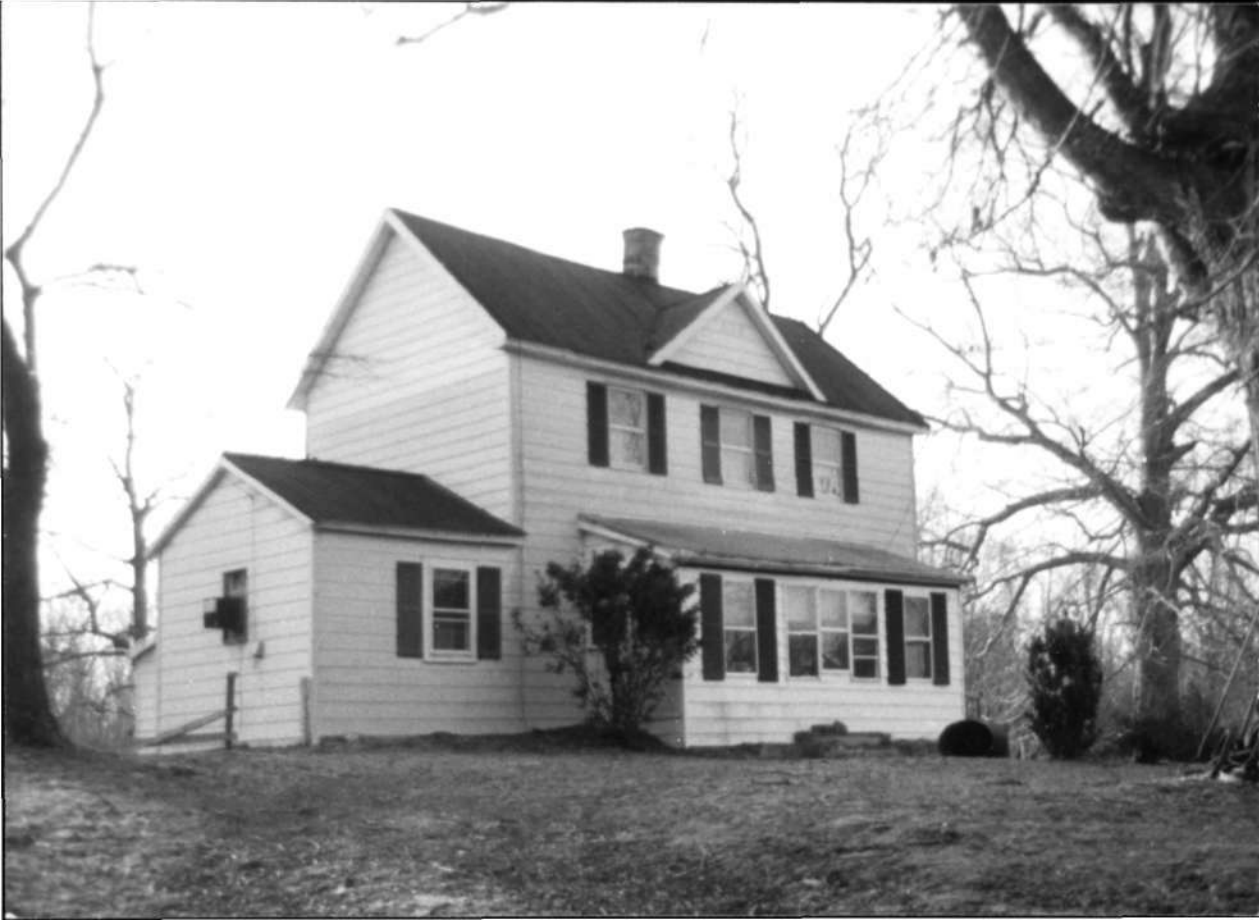
14 of 32

This house lies about 100 feet east of Croom Rd. It is a 2-story, 3x1-bay frame house with asphalt shingle roof and clapboard siding. It has a pedimented center gable and enclosed full length front porch.

Original Survey Number 24, Croom Rd. Weems House. (C), View to West

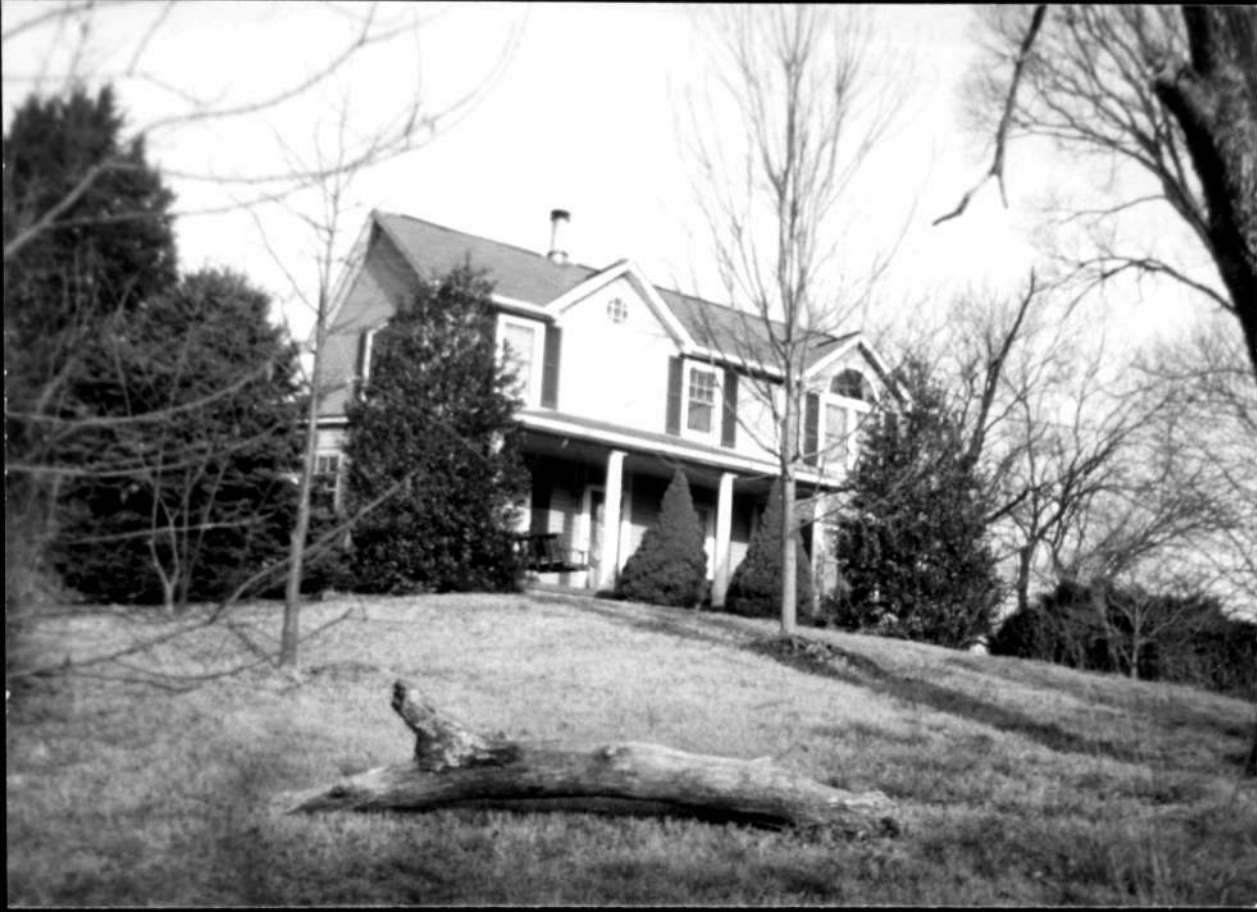
16 of 32.

Previously considered a contributing resource, this early-20<sup>th</sup> century dwelling is located west of Croom Rd. It is a 2-story, frame structure, three bays wide. Previously clad with brick veneer, the house is now clad with vinyl siding. Windows, originally 2/2 double-hung, are now 6/1 replacement sashes. The front façade has a 3-bay porch with hipped roof and round posts. There is a 1-story semi-octagonal bay on the south façade, and two recent pedimented cross-gable bays have been added to its front façade piercing the roofline. These additions and alterations have obliterated the integrity of design and materials of the original structure, making it a non-contributing resource to the historic district.

Original Survey Number 27, 9705 Croom Rd. (NC). Heavily  
altered structure originally classified as contributing prior  
to alterations. View to west.

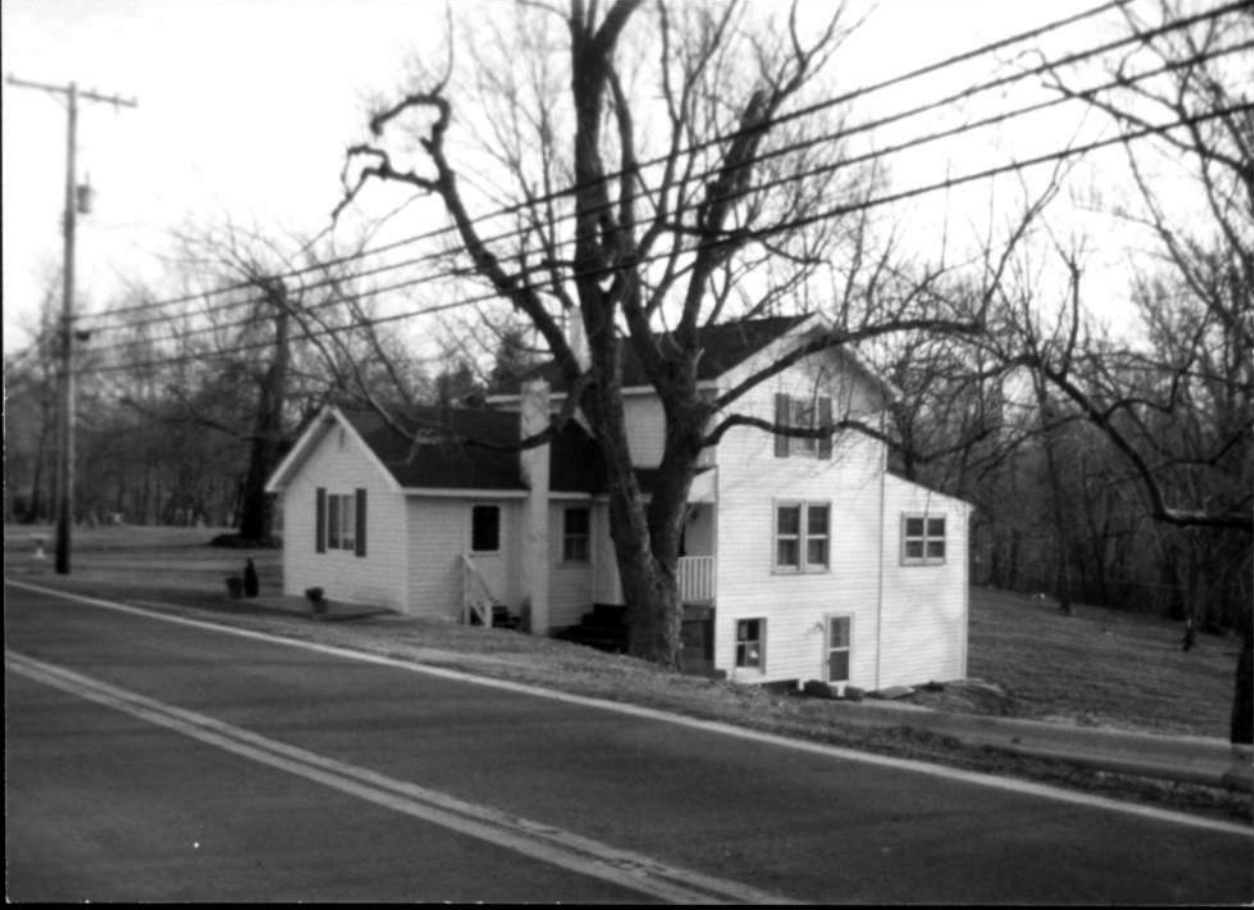
17 of 32

This early-20<sup>th</sup> century dwelling is a two-part building consisting of a 2-story, side gabled, 3x1-bay main section with a 1-story cross gabled entrance wing facing Croom Rd. The front wing is of more modern construction, and the 2-story section dates to the late 19<sup>th</sup> or early-20<sup>th</sup> century. Windows on the main structure are 6/6 double-hung, and the 1-story wing has vinyl clad casements. The entire house is clad with vinyl siding. The house, although altered, still possesses a main block having integrity of design and workmanship, and is therefore considered a contributing resource to the district.

Original Survey Number 29, 9710 Croom Rd. (C), View to North,

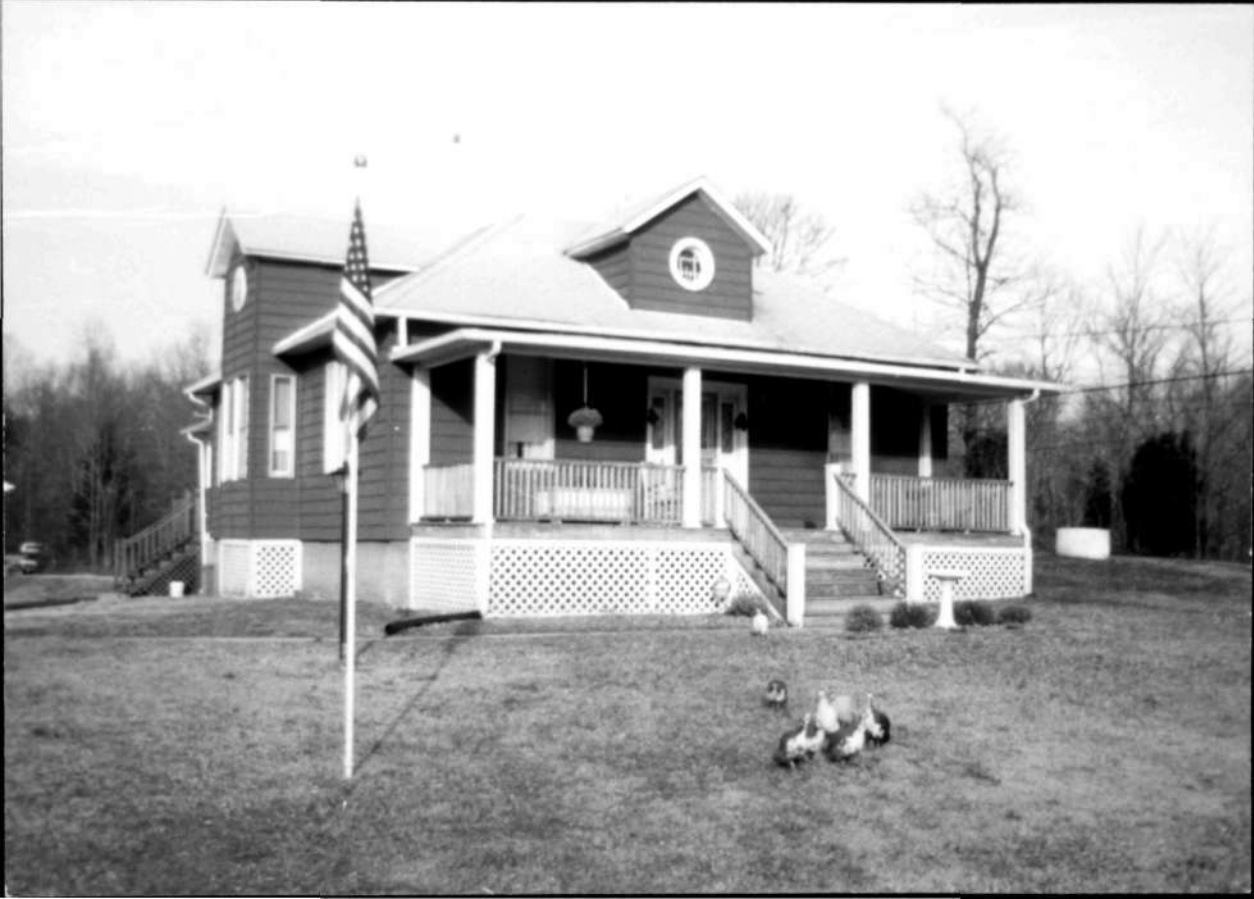
18 of 32

This is a 1 1/2-story, frame 3x3-bay Craftsman or Bungalow style dwelling. It has dormers on the south and east facades that pierce the hip roof. A full length front porch with square posts.

Original Survey Number 31, 9801 Croom Rd. (C), View to West,

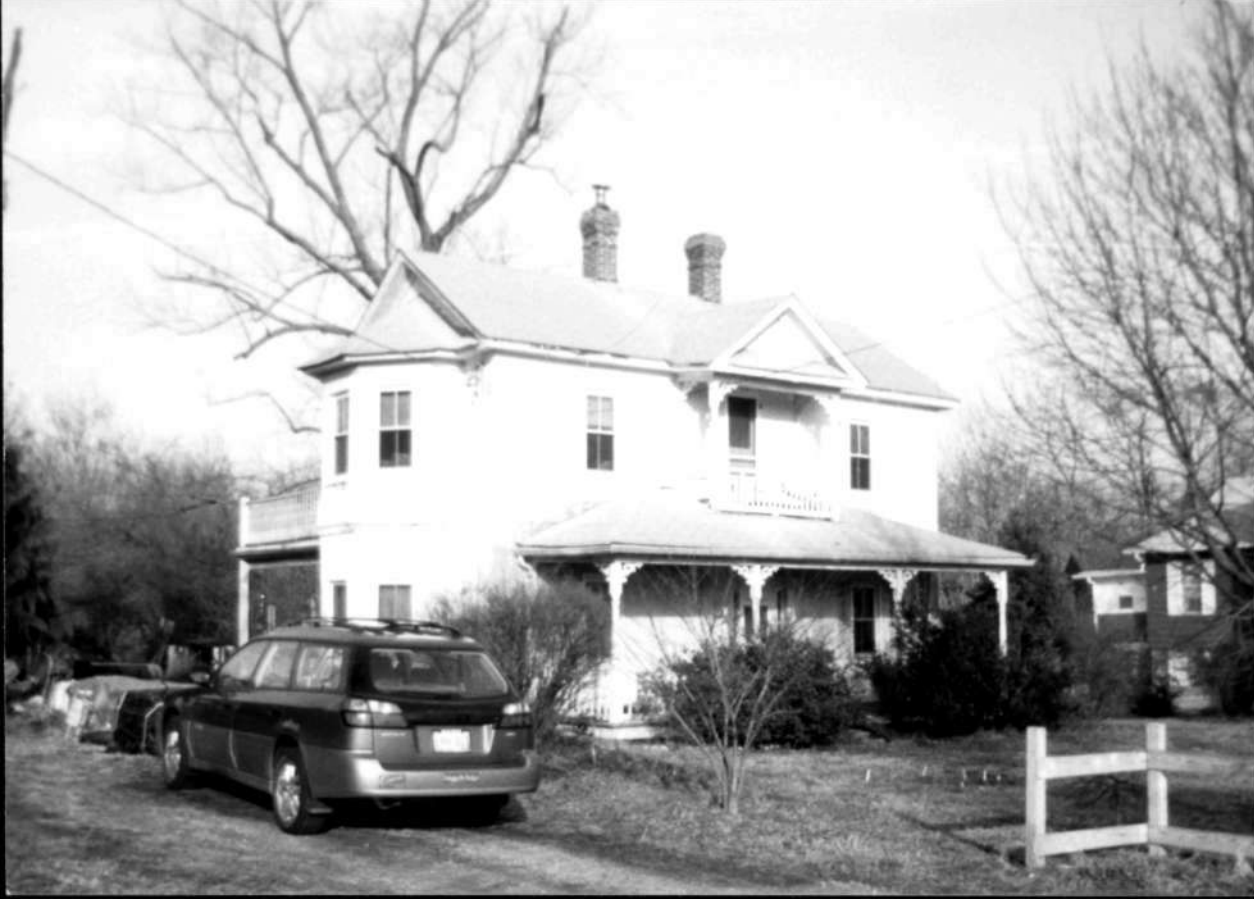
19 of 32

This house is a 2-story, 3x1-bay I house constructed in the late-19<sup>th</sup> century. It has a full-length front porch with turned posts and brackets. Above the porch is a center bay second story porch with pedimented gable. The south façade has a semi-octagonal, 2-story bay. The house is clad with stucco and has 2/2 double-hung windows. Retaining a high degree of integrity of materials, design, and workmanship, this house should be considered a primary resource to the historic district.

Original Survey Number 32, Halterman House, 9805 Croom Rd. (C),  
View to west.

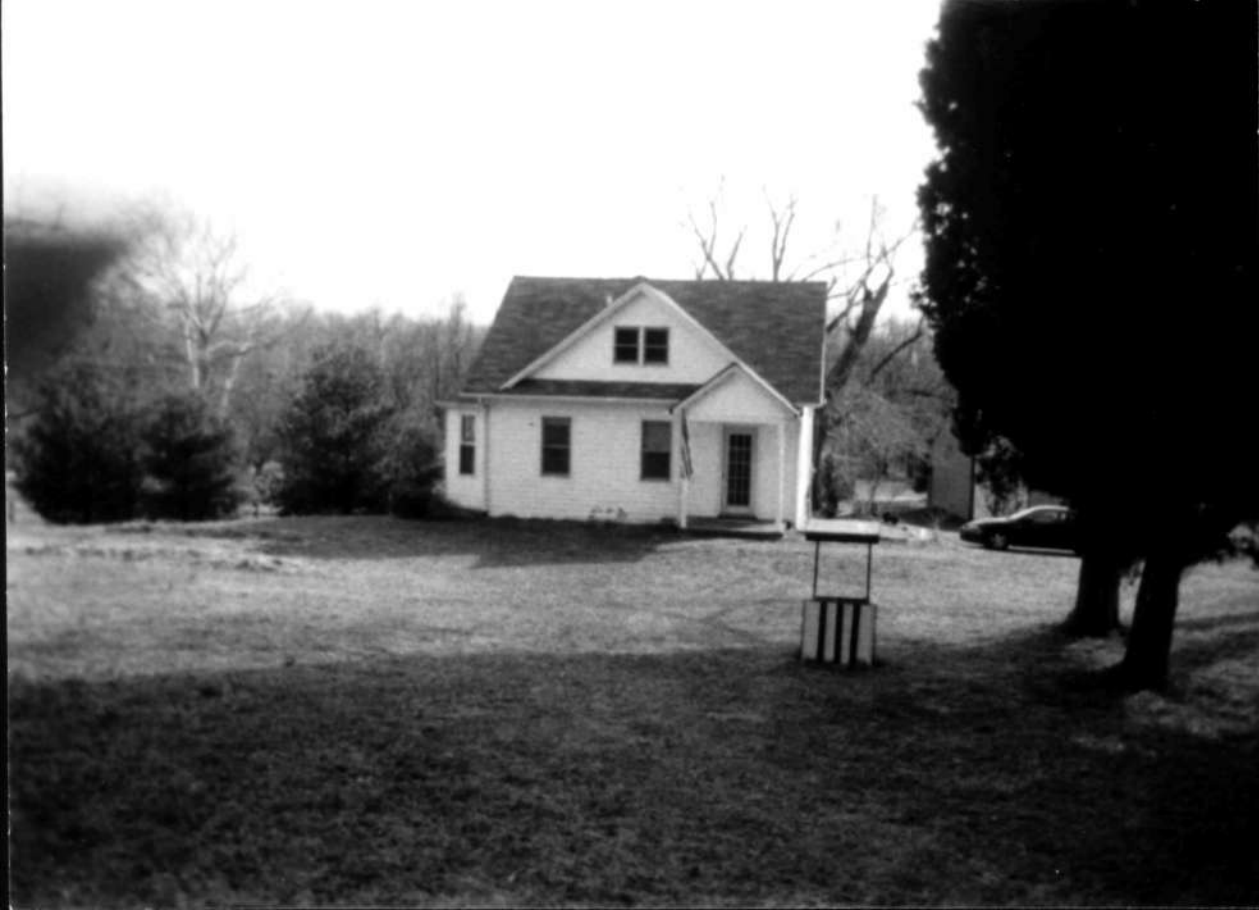
21 of 32

Original Survey Number 34, 9806 Croom Rd. (C), View to East,

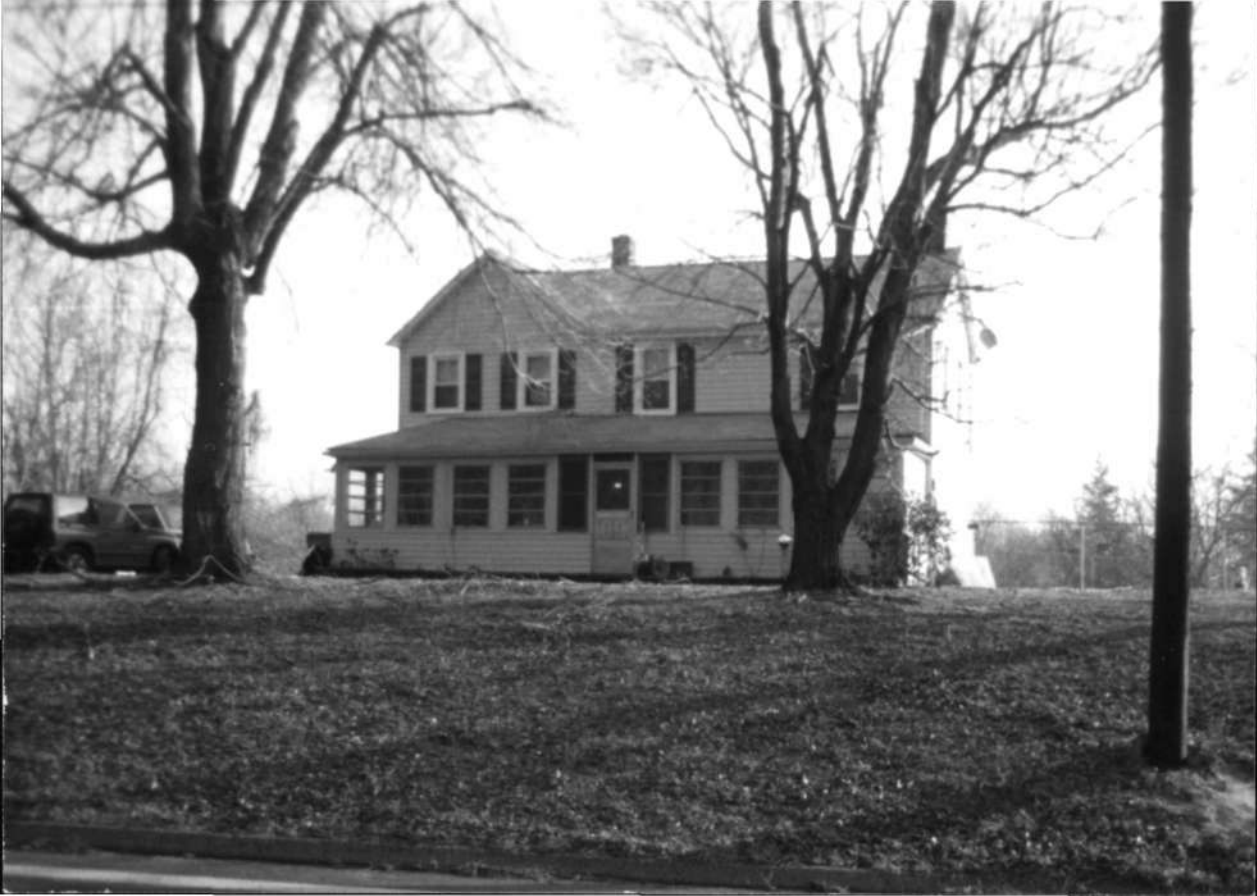
23 of 32

Original Survey Number 36, 9910 Croom Rd. (C), View to East
